## REMOVAL OF DAMAGED PIPES WITH WORN ENDS DURING MAJOR REPAIRS OF OIL AND GAS WELLS

©*Musavi S.*, Azerbaijan State University of Oil and Industry,  
Baku, Azerbaijan, *musavisaida@mail.ru*

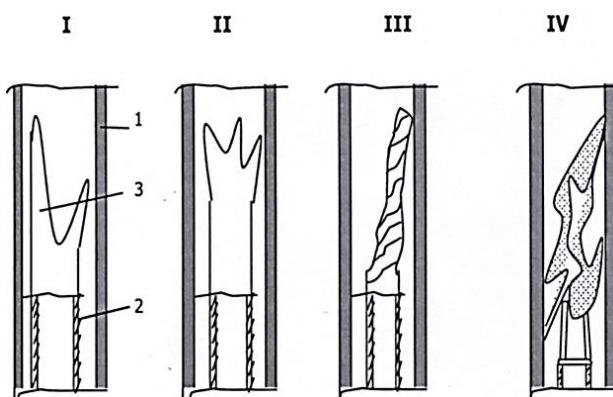
Figure 1. Deformed emergency pipe ends of complex configuration: 1 – operating column; 2 – emergency pipe; 3 – emergency end. I – opened in the shape of a “tongue”; II – opened in the shape of “flower petals”; III – twisted in the form of a ‘spiral’; IV – in the shape of a “colander”

Deformed emergency ends with complex configurations can be classified as follows: one or more opened in the form of a “tongue”; opened in the form of “flower petals”; twisted in the form of a “spiral”; in the form of a “colander” (numerous holes, dents, and cracks from corrosion), referring to the condition of the last pipes coming out of the well, forming a pile of small pieces (debris, fragments, strips, scale) accumulated next to and above the damaged end. Figure 1 schematically shows deformed emergency ends of complex configuration.

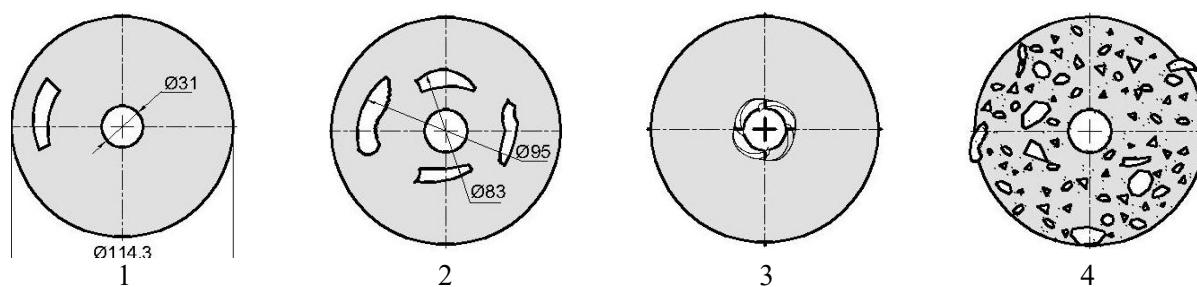
Figure 2. Impressions of deformed accident ends of complex configuration: 1 – opened in the shape of a “tongue”; 2 – opened in the shape of “flower petals”; 3 – twisted in the form of a ‘spiral’; 4 – in the form of a “colander”

Depending on the configuration of the deformed emergency end, corresponding marks appear on the seal. Figure 2 schematically shows the prints of deformed emergency ends of complex configuration on the seal. In emergency response practice, the most common method of extracting lift pipes with deformed ends from a well, judging by the imprint and after identifying the condition of the pipe end, which is severely deformed, and in order to create normal conditions suitable for gripping with the appropriate standard emergency pipe catching tool, the deformed pipe end is corrected, i.e., processed with different types of milling cutters in the following sequence: end mills, type FZ; ring mills, type FK.

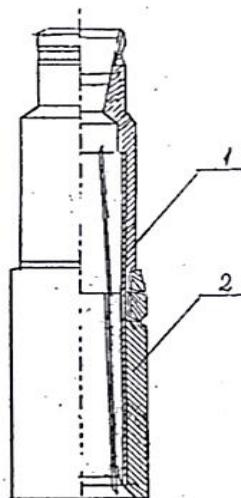
Figure 3. Combined bell type KK: 1 – bell K85-64; 2 – bell KS100

They are manufactured with a funnel thread at the bottom and a pipe thread at the top for connecting the receiving pipe. The proposed catching tool consists of two parts, i.e., a combination of two bells: a non-passable K85-64 and a passable KS100 bell (Figure 3).

In this case, since the object being caught is a 73 mm pipe, the type and sizes are selected accordingly. To connect the receiving pipe, there is a 102 mm (101.6 mm) pipe thread on the upper part of KS100. The K85-64 bell at the bottom has the same thread for the funnel. The standard (according to GOST 26-02 -1275-75) bell K100-78 with a lifting capacity of 850 kN has an outer diameter of 122 mm, i.e., it can be used in a 146 mm operating column and at larger diameters with the use of centering devices. The KS100 bell also has the same outer diameter [19].

As noted, the KK100-64 combined bell consists of: the K85-64 bell and the KS100 bell. The purpose of the K85-64 bell remains unchanged. In this design, the function performed by the KS100 bell differs from its direct purpose. The principle of operation of the KK100-64, which has a catch thread in the range of 100–64 mm, is as follows: the deformed emergency end of a complex structure (in the form of “flower petals,” “tongue”) is first processed by the KS100 bell, by rotation and a certain load, as a result of bending, crushing and gathering the deformed ends in the center, achieving a cylindrical shape and deepening the end of the pipe inward, i.e., by inserting it from above into the K85-64 bell to the corresponding nominal diameter of the 73 mm pipe body and grip, cutting the thread by screwing, and extracting the emergency pipe in a single operation [20].

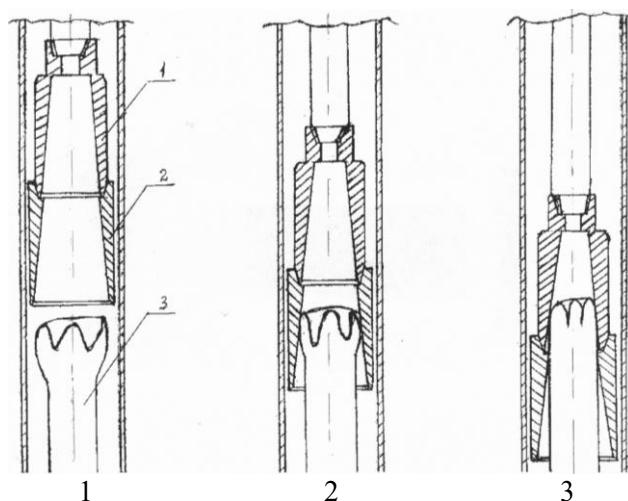
Figure 4. How the combined bell works: 1 - K85-64 bell; 2 - KS100 bell; 3 - deformed emergency end of complex design (in the shape of “flower petals”)

Figure 4 schematically shows the operating sequence of a KK-type combined bell. Unlike fishing with a conventional bell, the first stage of the operation when using a combined bell is to assemble the broken open end of the pipe using a through bell 2 (KS100) to obtain and restore the nominal cross-section for fishing. By flushing and slowly lowering (Figure 4, stage 1), the depth of the broken end 3 is fixed and the landing point of the load within 3-5 kN is marked (measured) on the drive drill pipe (DDP).

As the distance between the corrected end and the combined bell increases, i.e., as the upper end of bell 1 enters, the second stage is performed—the operation of catching the emergency pipe (Figure 4, stage 3). After capture, the degree of tool attachment is determined depending on the condition of the emergency pipes (meaning the condition of the previously extracted pipes). In the first stage of operation with a combined bell, there are undoubtedly elements of working with a ring cutter. Unlike ring cutters (which have an internal cylindrical shape), the combined bell has the ability to collect in the center (by bending, crushing) due to the internal conical shape of the through bell, which is part of the combined bell. As the distance between the emergency end and the bell increases, the repaired part of the pipe takes on a conical shape. Due to the increase in the contact area with the non-passable bell, a more complete and reliable catch of the emergency pipe is achieved. Figure 5 shows a 73 mm pipe with a tongue-shaped emergency end, assembled as a roll, after processing, gripping, and extraction from the well using a combined bell (Figure 1, 2).
